Morphology, Dynamics and Hazard Management of the New River Lagoon, Westland, New Zealand

A thesis submitted in partial fulfilment of the
requirements for the Degree of
Master of Science in Geography
at the
University of Canterbury

Michael J. Fifield

**Department of Geography
University of Canterbury
Christchurch, 2012**

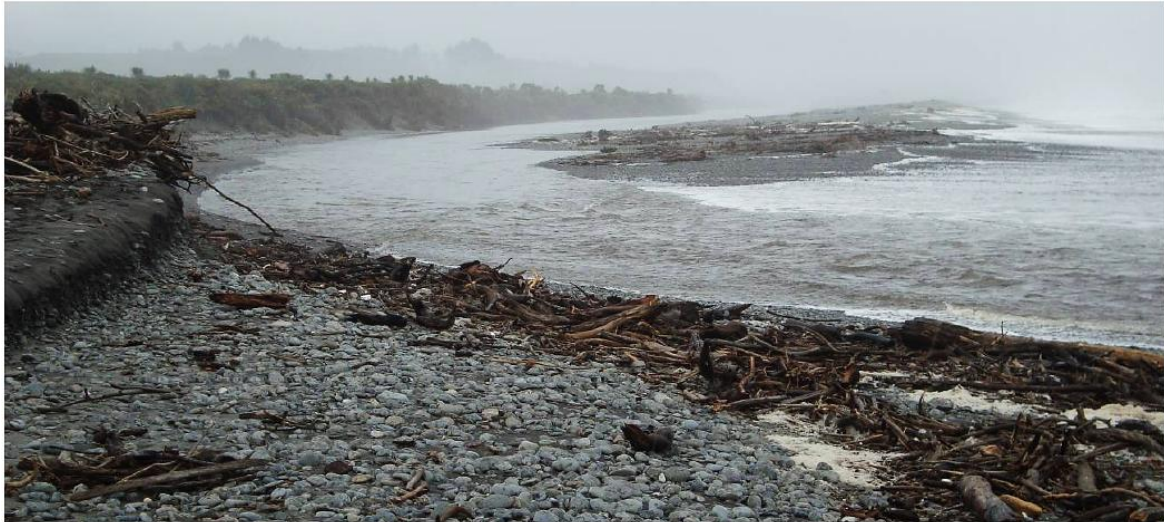
Figure 1.5. Formation of a gravel bar as the lagoon outlet migrates north, creating a barrier between the lagoon channel and the sea and forcing the river to erode its outside banks (Source: Smart, 2010 pg. 5)

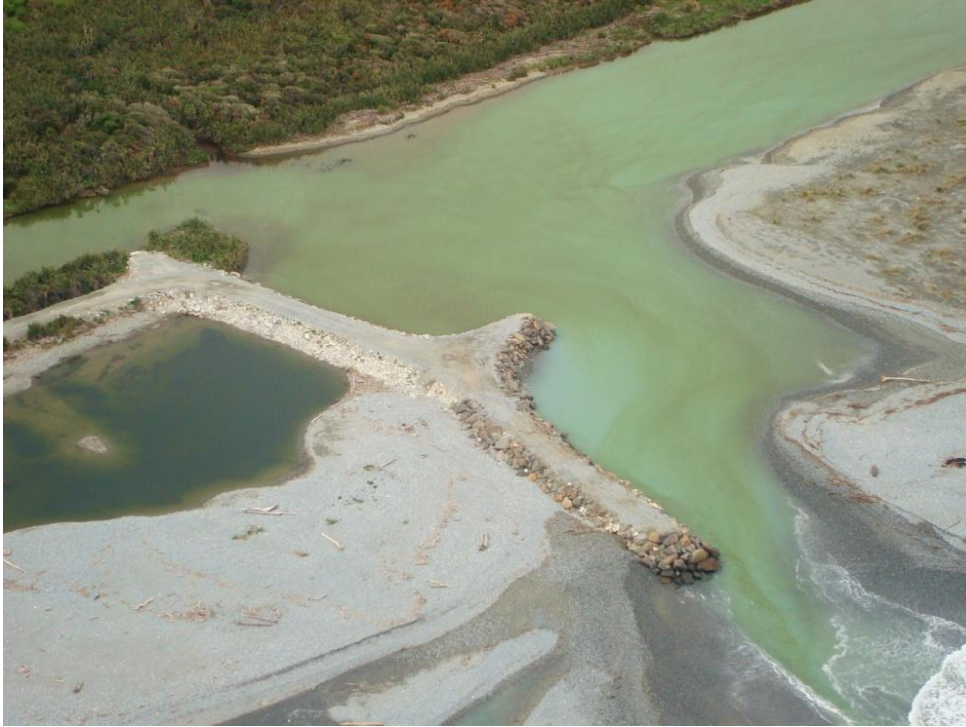
Figure 1.6. Artificial lagoon outlet and rubble-mound breakwater at the confluence of New River and Saltwater Creek (photo courtesy of Laurie Anderson, 23/05/2011)

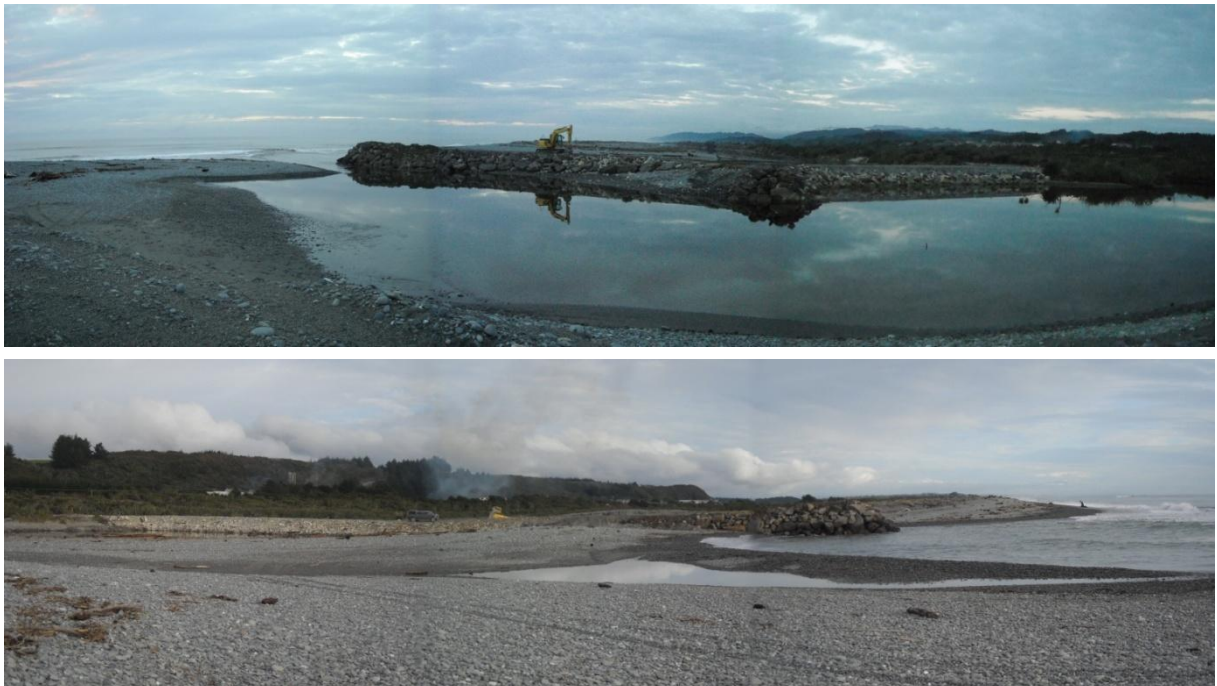
Figure 1.7. Artificial lagoon outlet and rubble-mound breakwater looking north (above) and rubble-mound breakwater and updrift beach looking south (below) (23/05/2011)

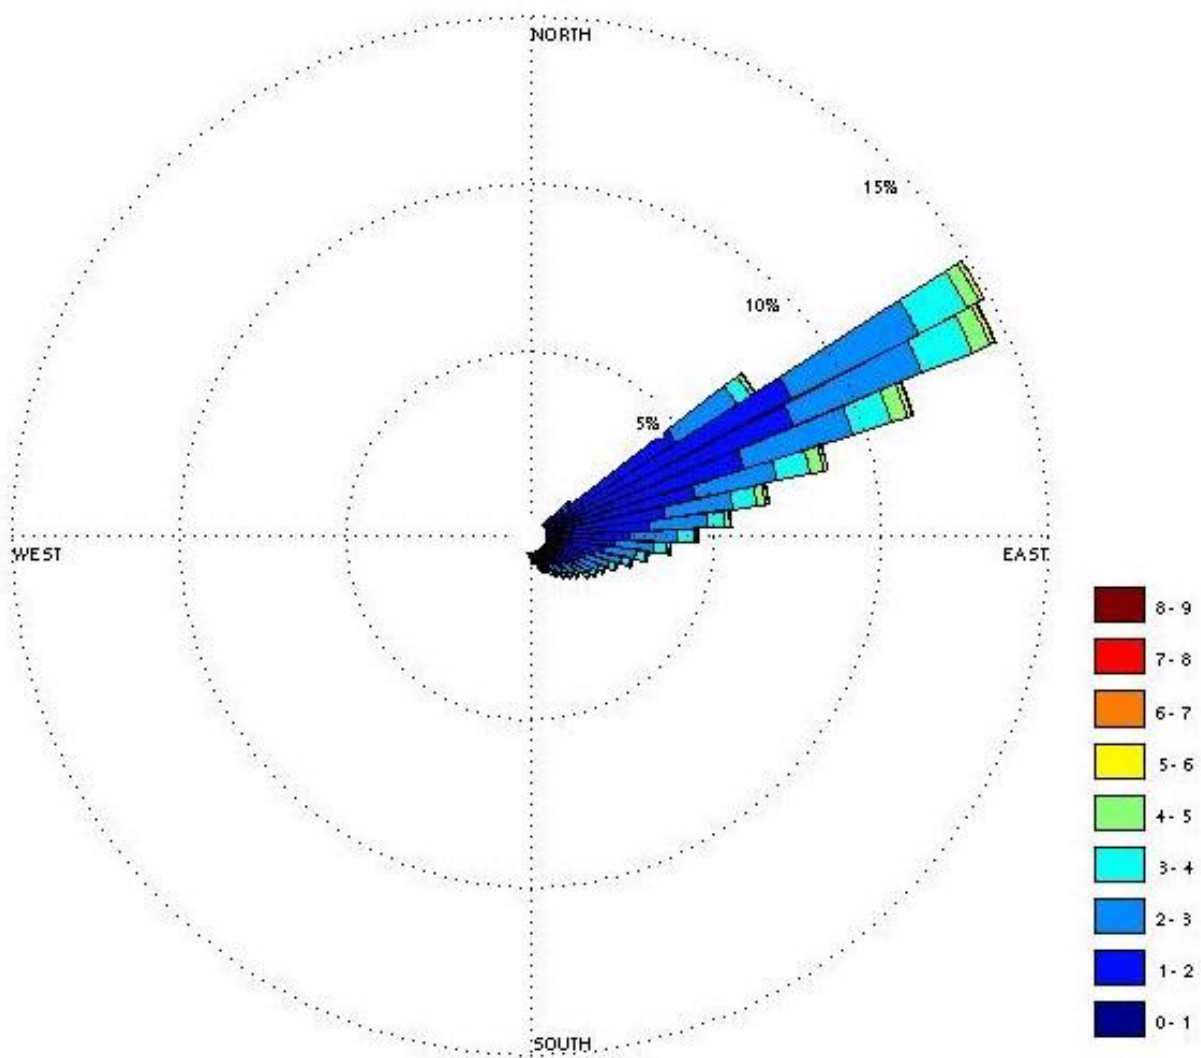
Figure 2.4. Frequency of wave height and wave direction west of the New River Lagoon, 1979-1999 (Latitude -42.557° S, Longitude 171.065° E)

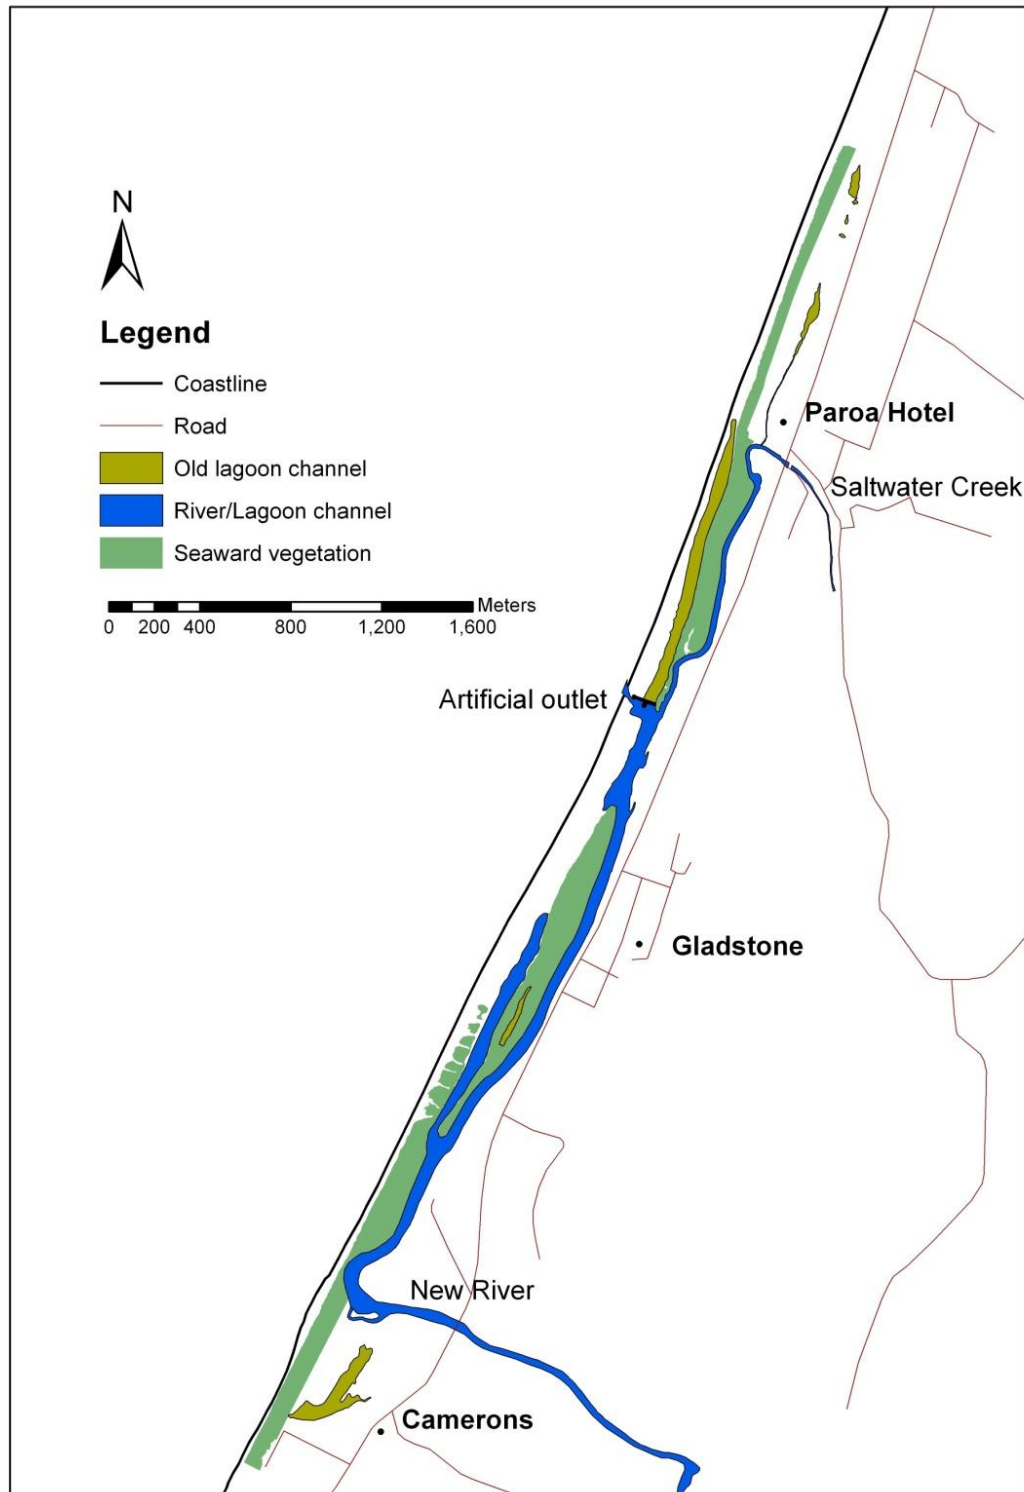
Figure 2.5. New River Lagoon site map showing past and present lagoon channels (features digitised using a georeferenced 2010 aerial photograph)

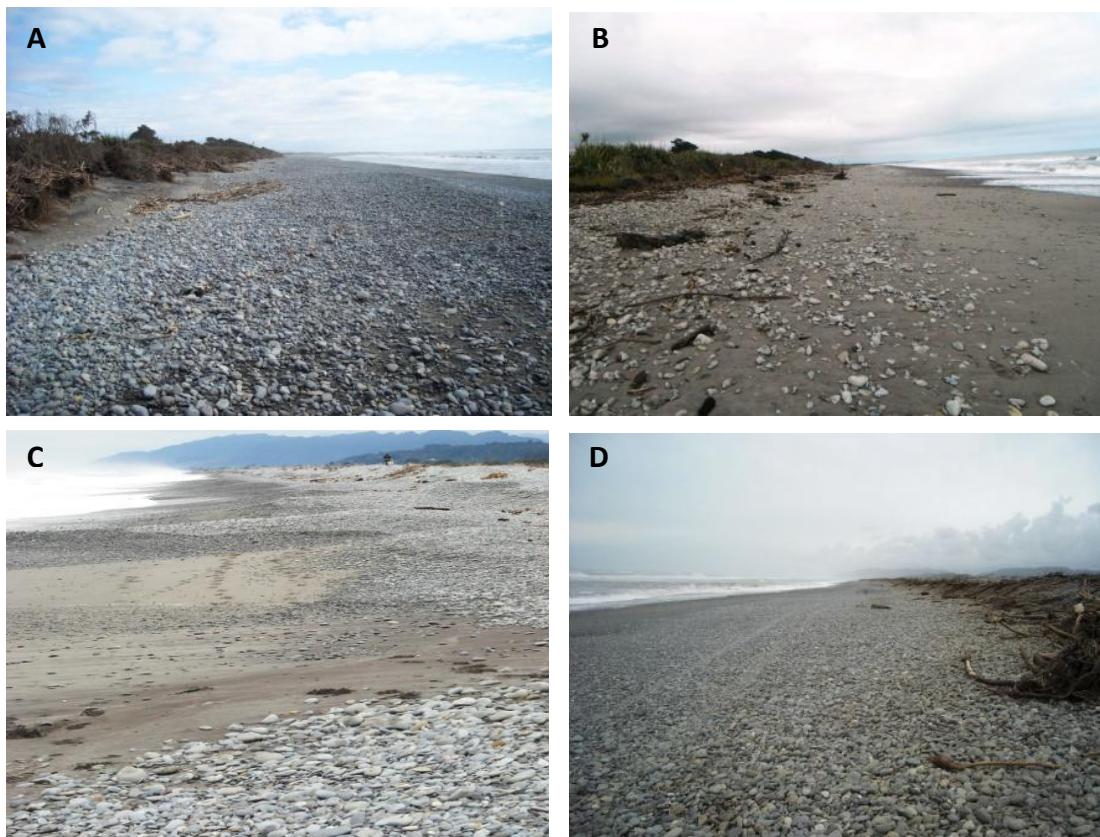
Figure 2.7. Beach environment fronting the New River Lagoon. A) Barrier beach immediately south of the New River Bridge. The berm is relatively low lying and the landward extent of vegetation cover extends close to the beach. There is evidence of scouring of the back beach due to storm surge and a lack of built-up protection (27/10/2011). B) The same stretch of beach 4 months later. Note the change in sediment composition from predominantly gravel dominated to sand dominated (02/03/2012). C) Barrier beach north of the lagoon outlet is steep and wide (04/08/2011). D) The same stretch of beach 7 months later. Sediment composition has changed from composite sand and gravel to dominant gravel (02/03/2011). Note the alongshore differences in sediment compositions between photos C and D, both taken on the same day.

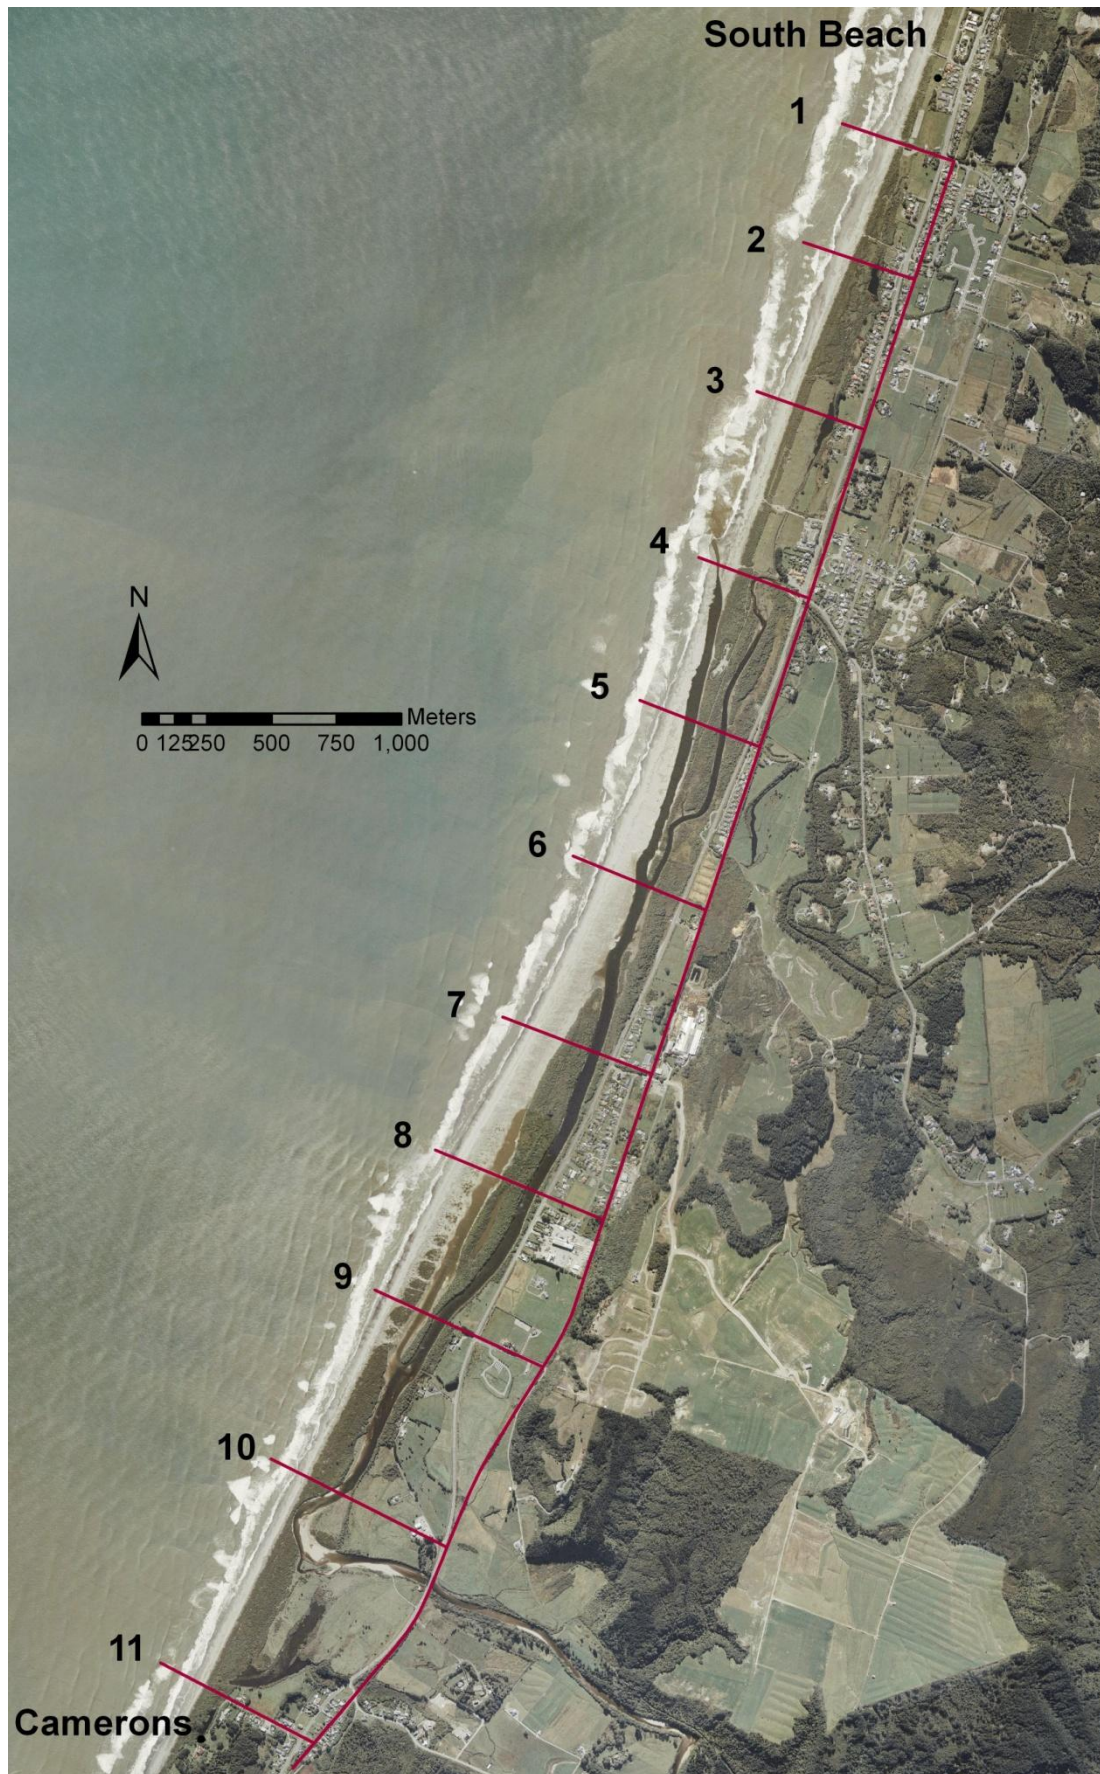
Figure 4.1. Beach profiles 1 to 11 covering the extent of the coastline between Camerons (in the South) and South Beach, north of the Paroa Hotel

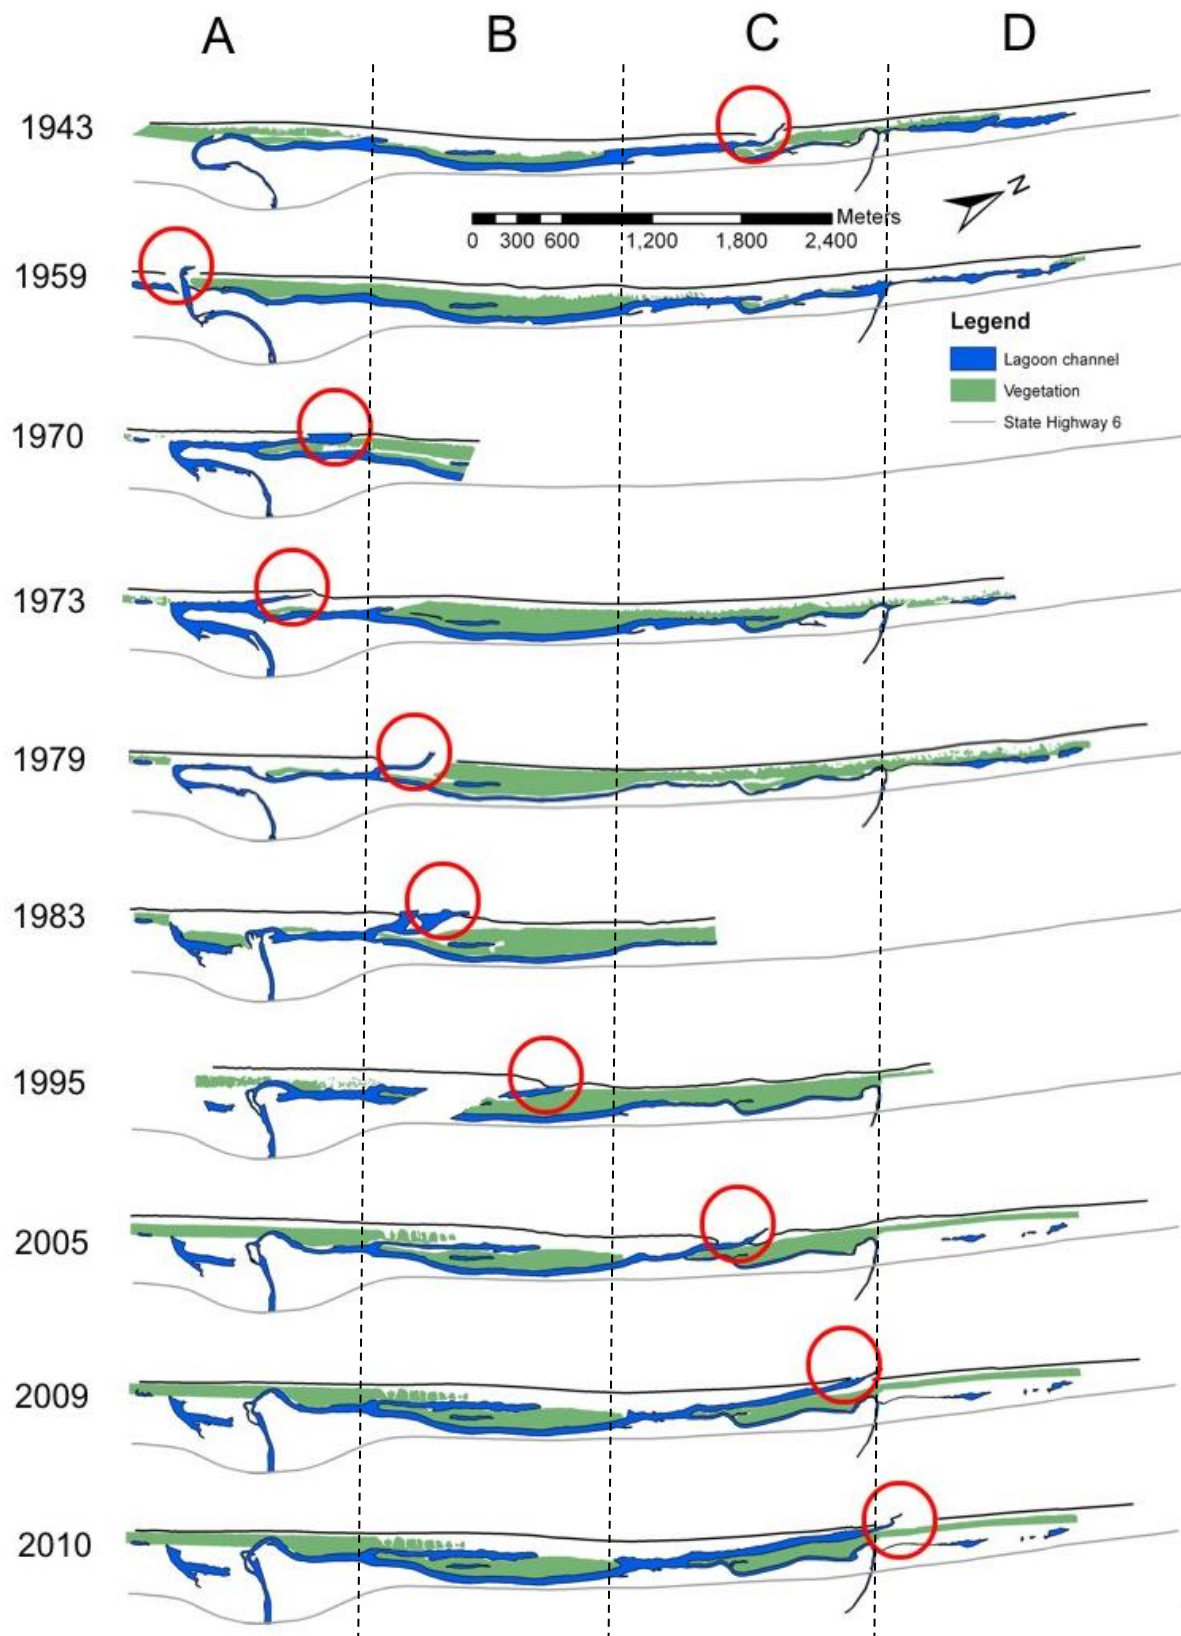
Figure 4.3. New River Lagoon occupied and unoccupied channels and the seaward extent of vegetation cover from 1943 to 2010. Images have been digitised from a 2010 orthorectified aerial photograph and outlet positions circled in red.

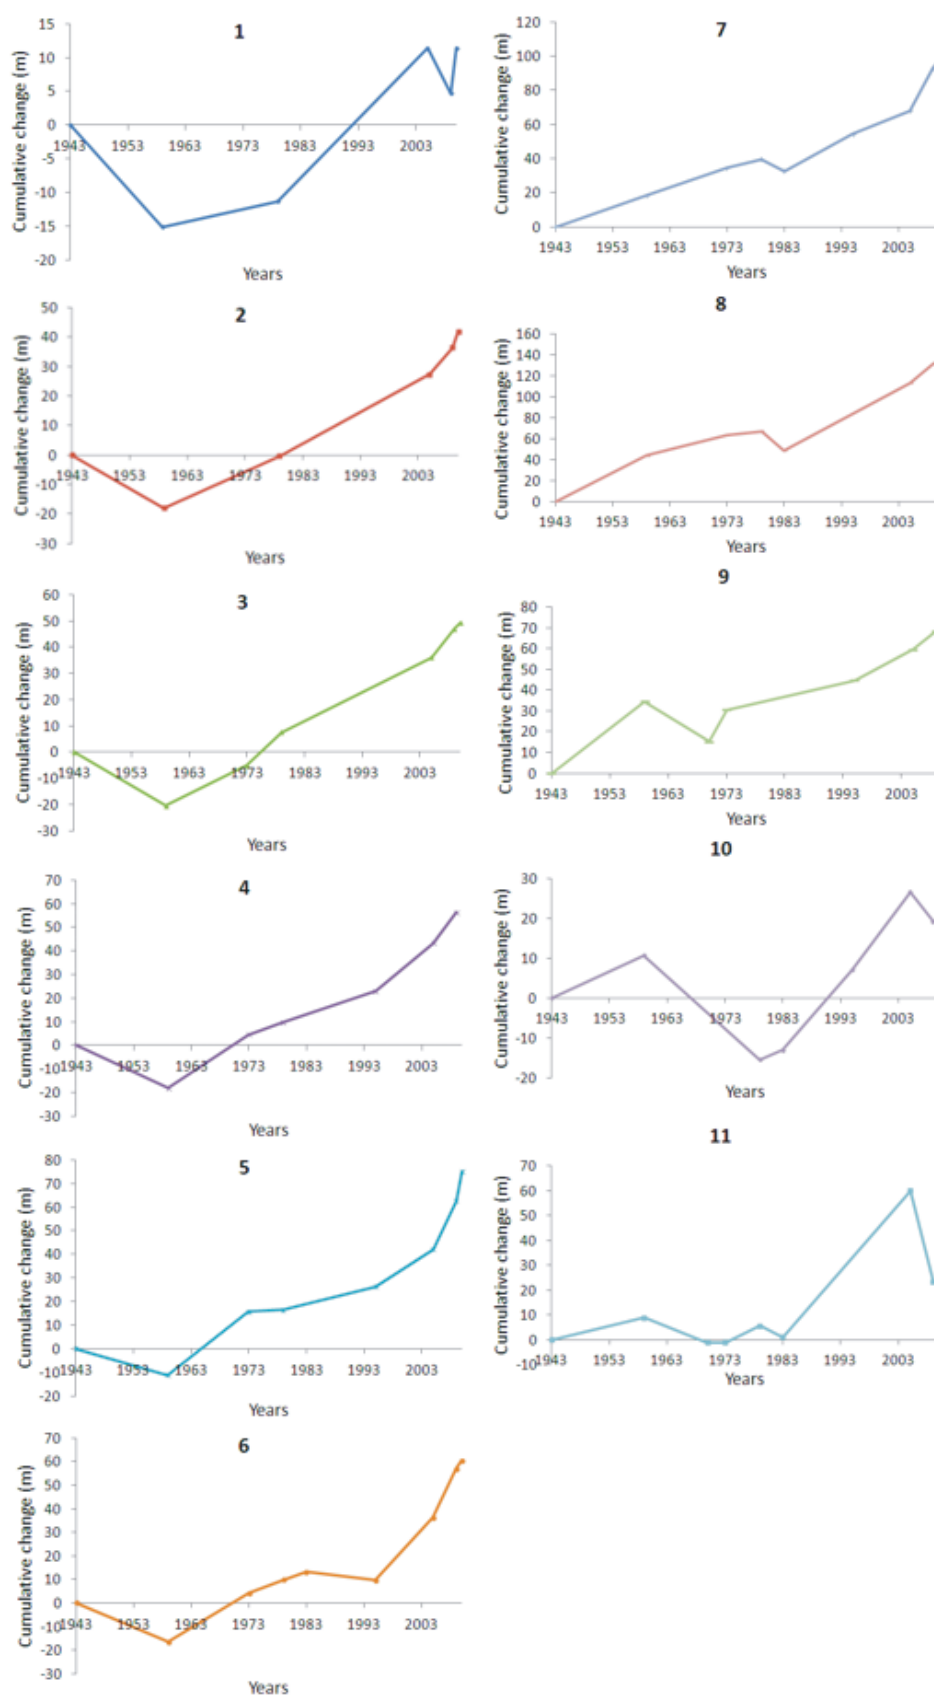
Figure 4.4. Cumulative change in the beach crest position of profiles 1 to 11 from 1943-2010. Note: positive slope of lines show progradation (seaward movement), while negative slopes indicate retreat (landward movement) of the berm crest.

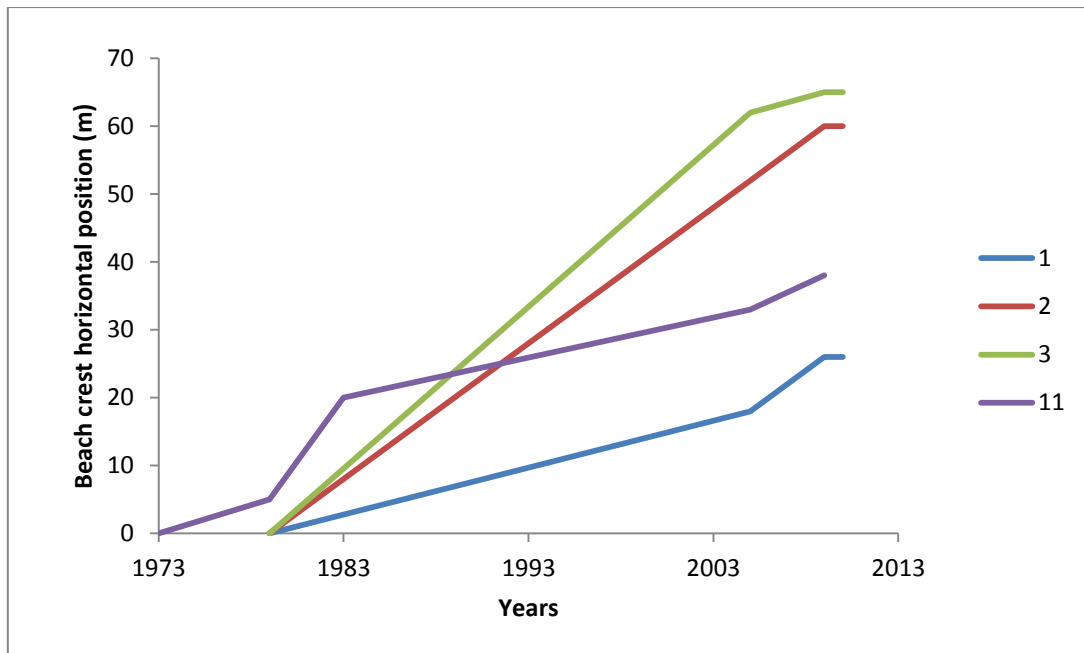
Figure 4.5. Cumulative change of the vegetation line of profiles 1-3 from 1979-2010 and profile 11 from 1972-2010. Note: positive slope of lines show progradation (seaward movement) of the position of the seaward edge of vegetation.

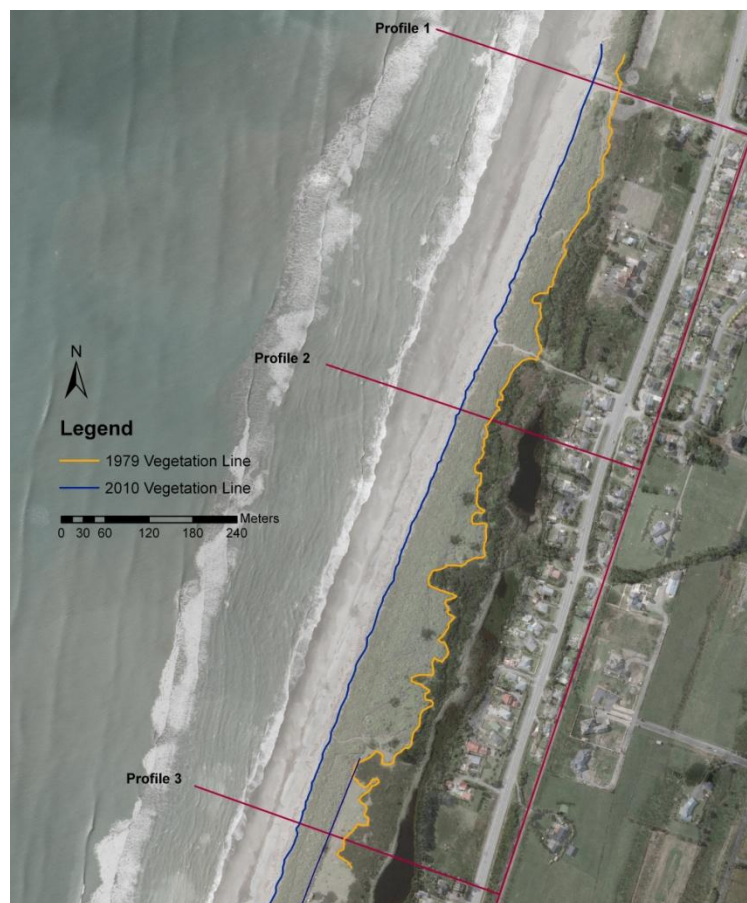
Figure 4.6. 2010 orthorectified photograph overlying a 1979 orthorectified photograph shows the progradation of the vegetation line at profiles 1 to 3, north of the Paroa Hotel.

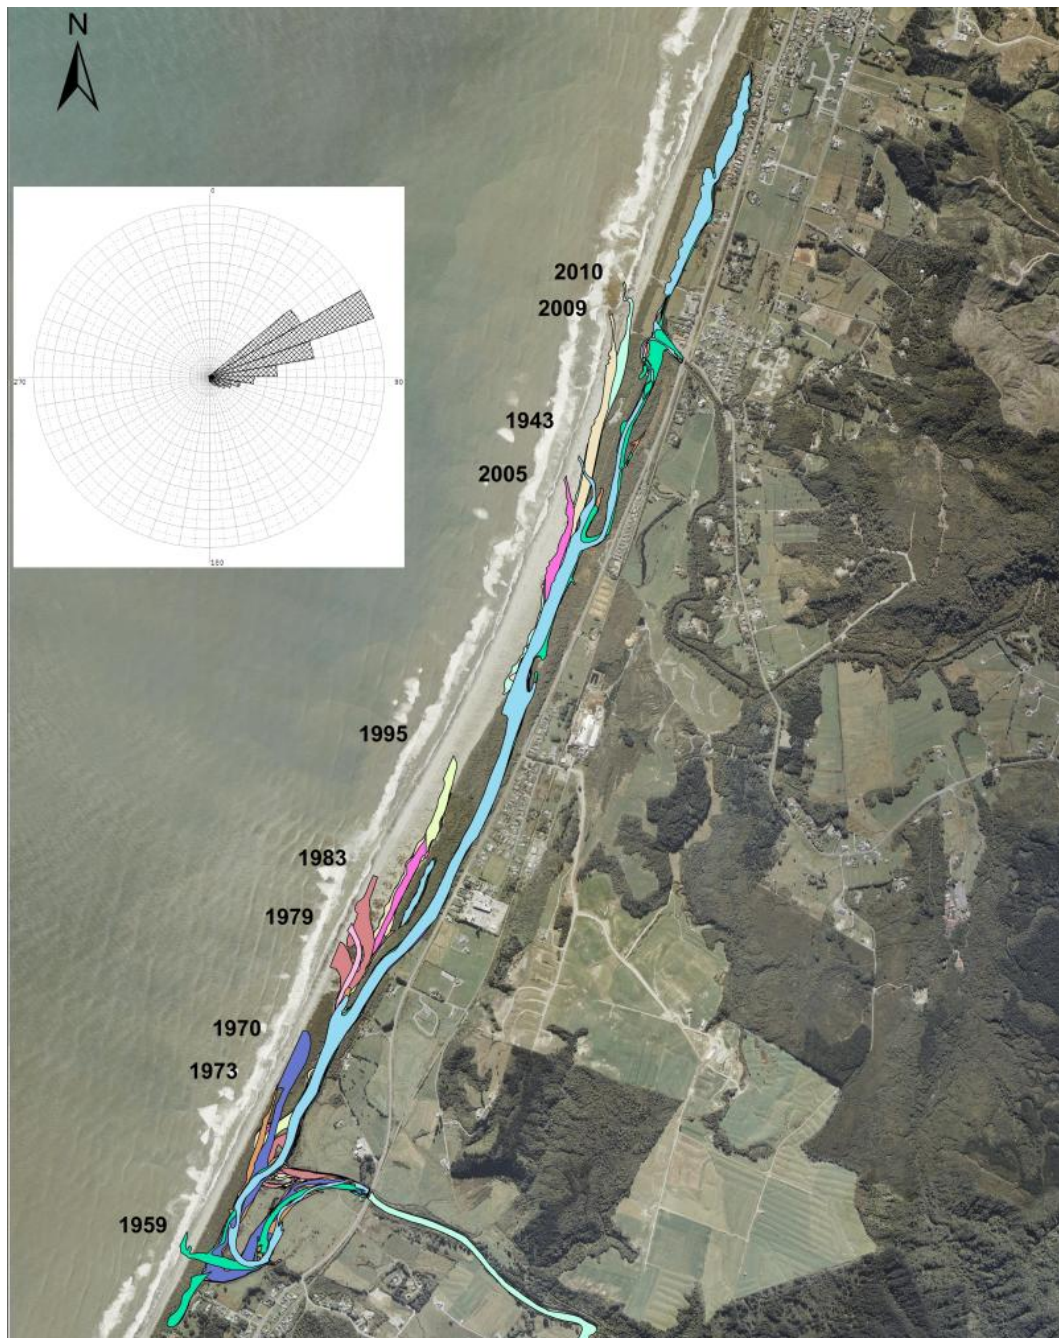
Figure 4.7. Northward movement of lagoon outlet positions from 1943 to 2010 and a wave rose showing a high frequency of waves traveling in an E/NE direction causing northward migration of the lagoon outlet.

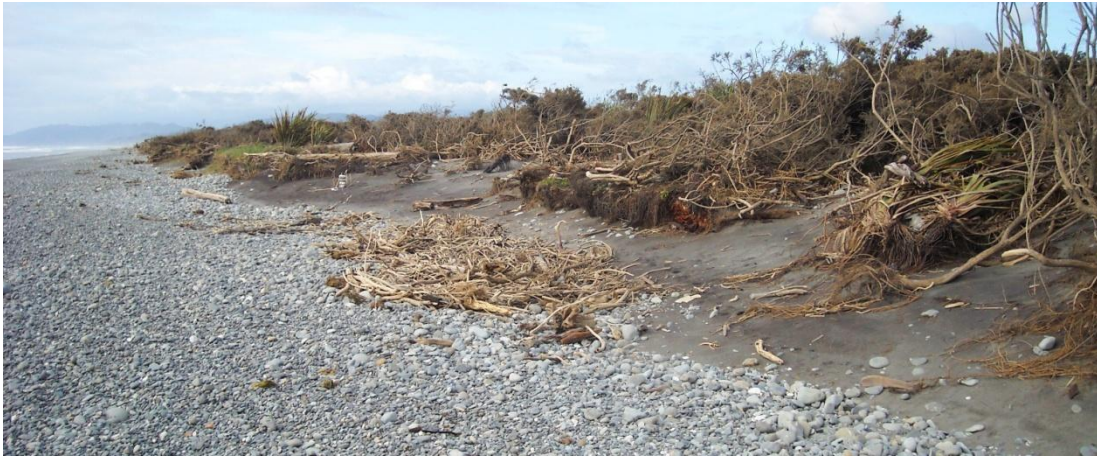
Figure 4.8. Landward erosions north of the New River Bridge (27/11/2011)

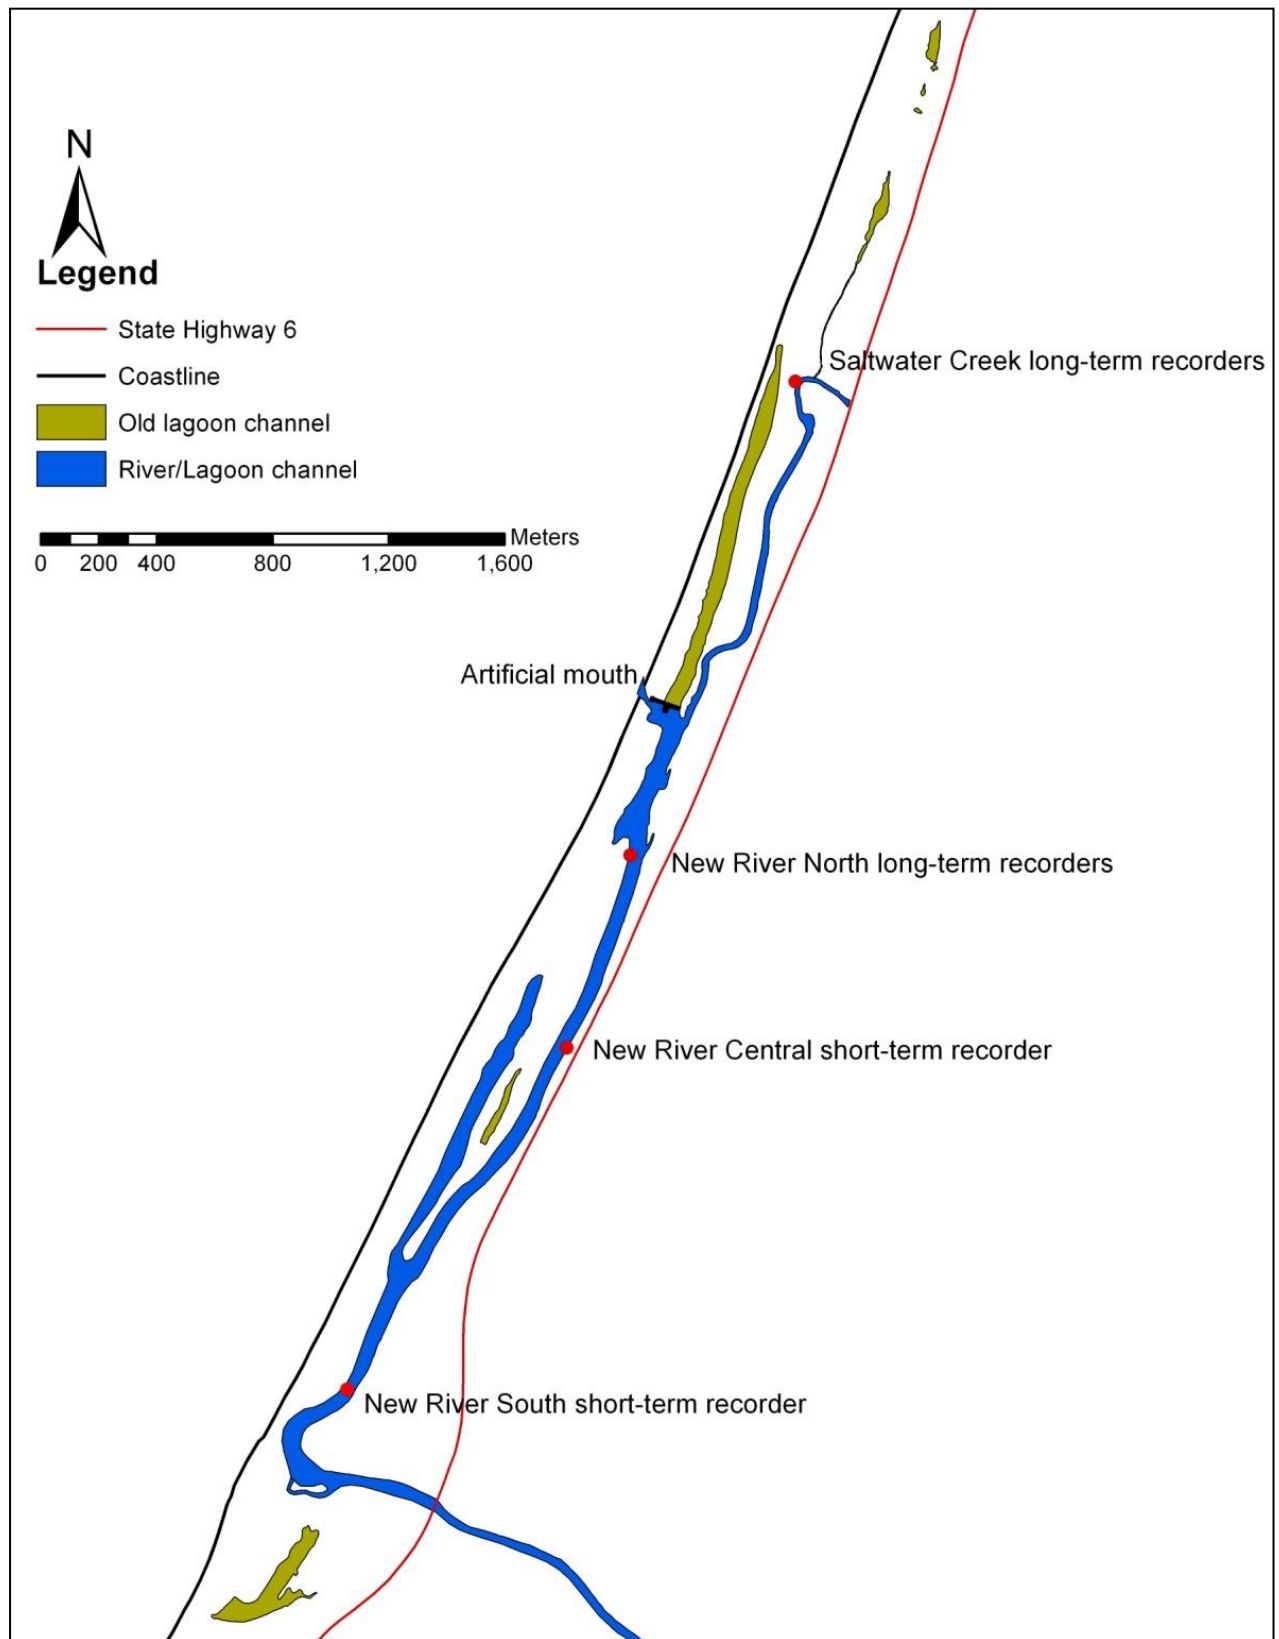
Figure 5.2. Location of long- and short-term water level recorders

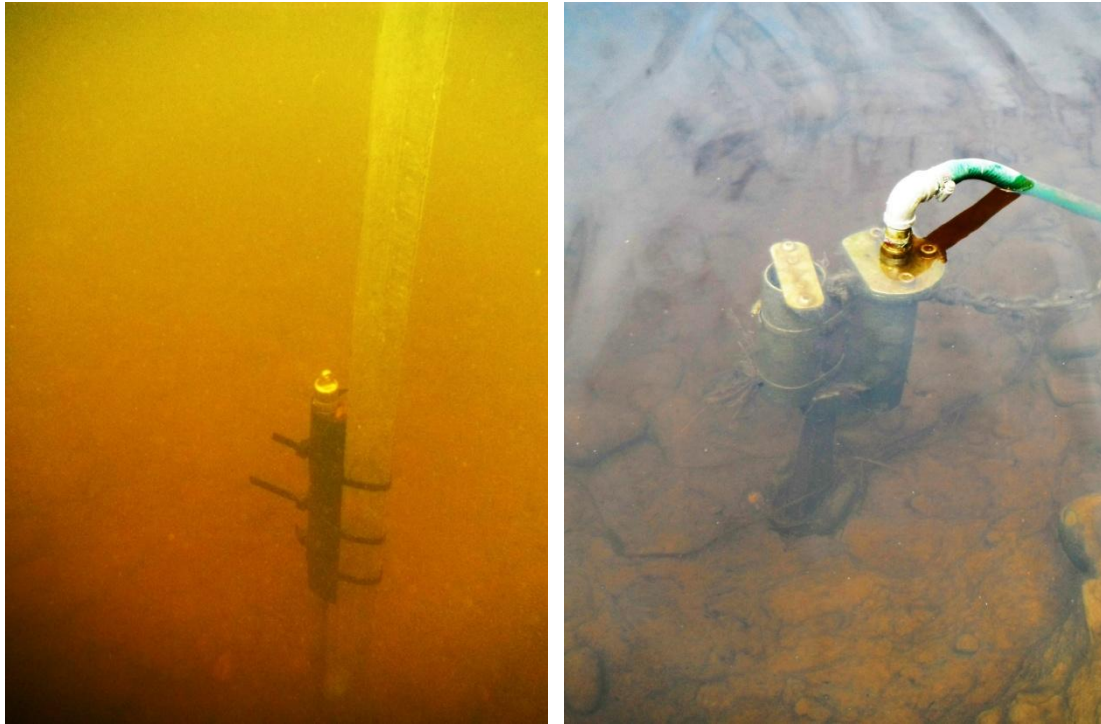
Figure 5.3. To the left is the short term water level, temperature and salinity recorder fastened to a steel pole and to the right is the long term water level, temperature and conductivity recorders, both encapsulated in steel brackets and fastened on either side of a steel pole (05/03/2012).

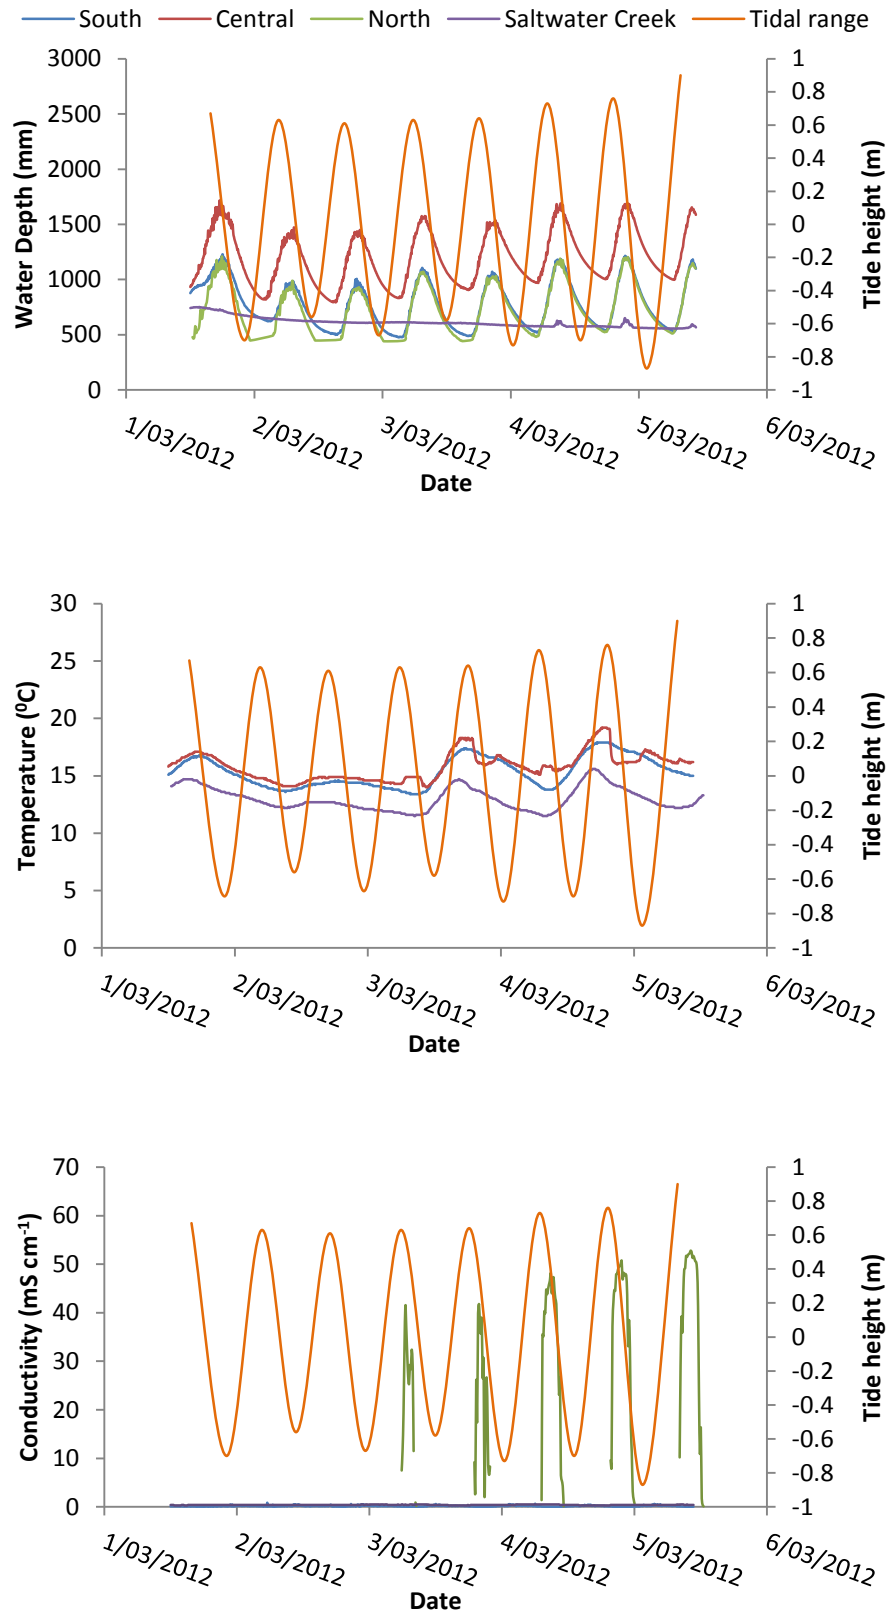
Figure 5.6. Short term water level, temperature and conductivity recordings in relation to tidal range, between the 1st March and 5th March 2012 for the recorders in the New River Lagoon. Note that negative values of tidal height indicate low tide and positive values of tidal height indicate high tide.

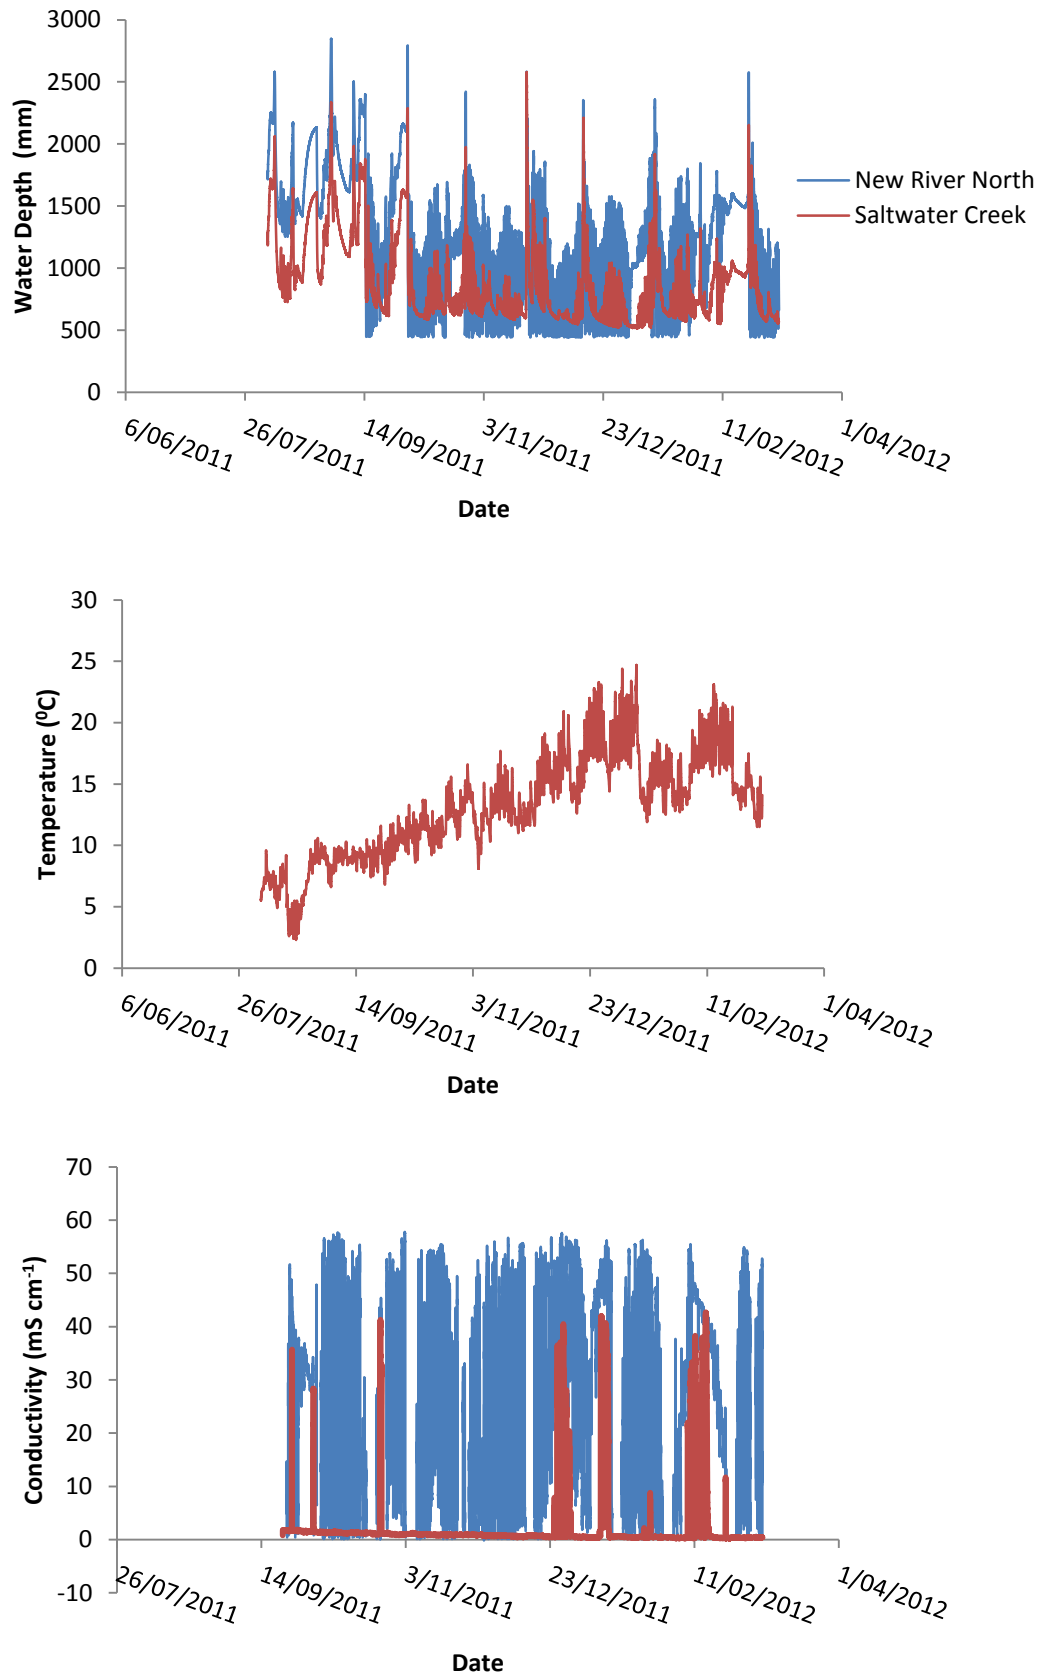
Figure 5.7. Long term water depth and temperature recordings between 4th August 2011 to 6th March 2012, and conductivity readings between 21st September 2011 to 6th March 2012, at Saltwater Creek and New River North

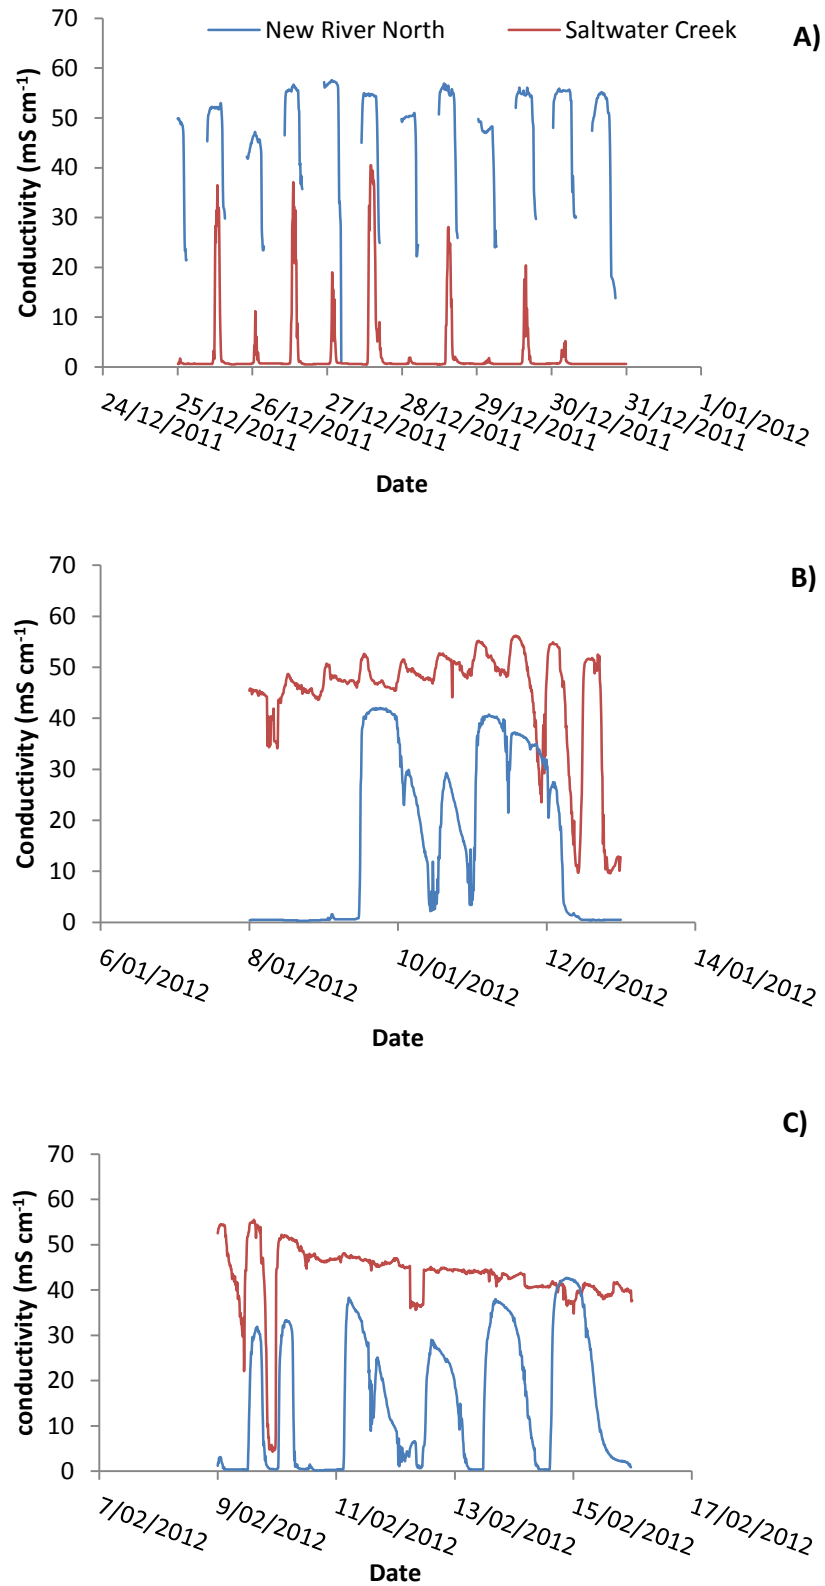
Figure 5.8. Periods of increased conductivity levels at Saltwater Creek and New River North. Image A shows distinct tidal influences at both recorders between the 25th and 30th December and images B and C show conductivity levels to be unusually high for prolonged periods at Saltwater Creek, whilst New River North has consistently high conductivity levels, between the 8th and 13th January and 9th and 15th February.
